Coatings For Industry, Inc.

Badly Deteriorated Concrete Floor In Truck Repair Facility Restored With Polyurethane Coating Expected To Last Many Years

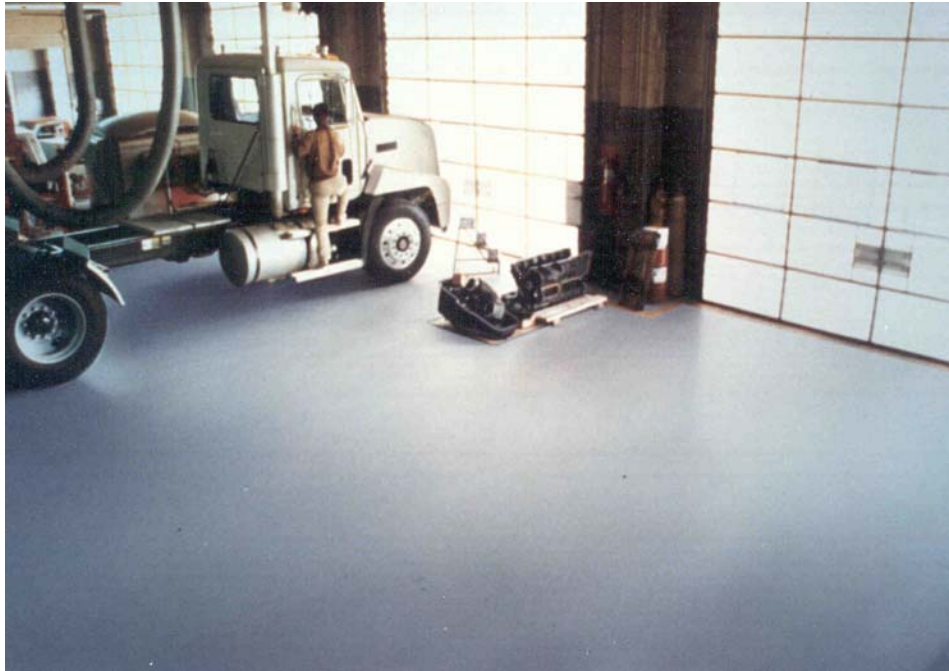
Photo: In the tough York Mack environment, the two-component polyurethane floor coating provides good color and gloss retention, as well as excellent resistance to solvents, chemicals and abrasion.

Regularly exposed to rough treatment, the main floor of the truck repair facility of York Mack, Inc., in York, PA, had deteriorated badly over the years. It was restored to “better than new” condition using specially formulated resurfacing and coating systems.

To resurface the concrete, an epoxy sand-filled matrix, **Wearcoat 805**, from **Coatings For Industry, Inc. (CFI)**, of Souderton, PA, was used. Then, a special gray-pigmented polyurethane coating system, **Urethabond 111**, also supplied by **CFI**, with exceptional wear and chemical resistance properties, was applied as both intermediate and topcoat.
